# Manhole Inspection Summary

Manhole # S65S\_\_007MH

Insp Date: **3/6/08 11:40 AM**

**Location** Address: **1501 Danville Ave.**

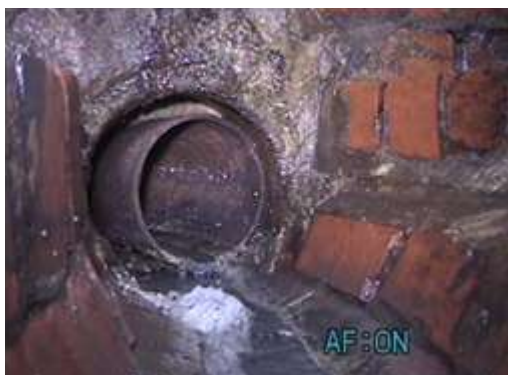
Defect 3

Questionable pipe seal. Looks like it's missing something. incoming 9 O'Clock pipe

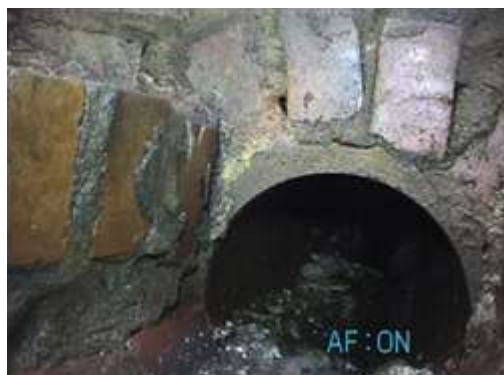
Defect 2

Cracked pipe seal outgoing 12 O'Clock. 11:00-1:00

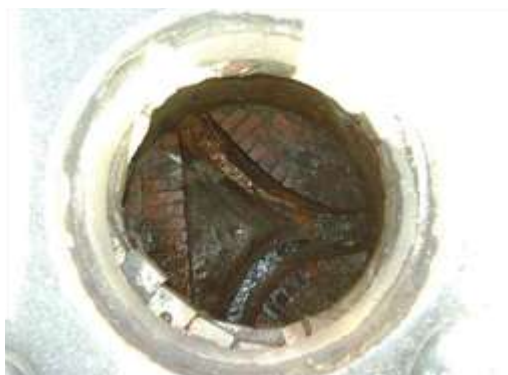
Offset: **2** (in.)

Offset frame defect

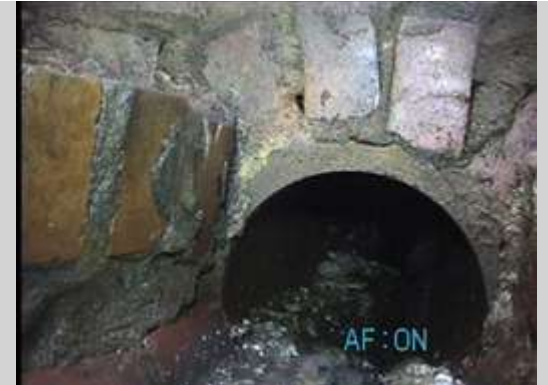
12 O'Clock Outflow

8 in. Circular Gravity Sewer  
Pipe Out @ 12 O'Clock

Pipe Height: **8.4** (in.) Rod and Bar (Angled)  
Pipe Material: **Clay** ☐ Pipe Lined  
Invert Depth: **6.83** (ft.) Flow Characteristics: **Slow**  
Deposits: ☒ None ☐ Mud ☐ Gravy ☐ Debris ☐ Grease  
Silt Depth: (in.) Deposits Extent:  
Infiltration: **Evidence** Pipe Seal Cond: **Cracked**

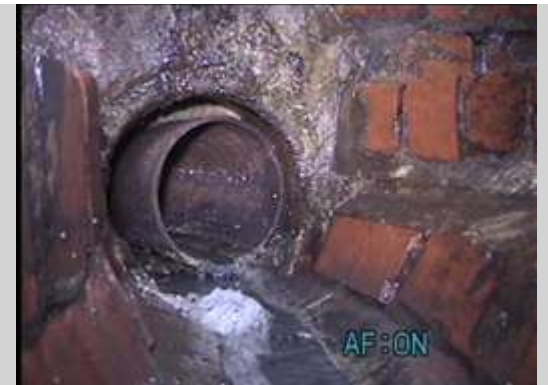
3 O'Clock Inflow

6 in. Circular Gravity Sewer  
Pipe In @ 3 O'Clock

Pipe Height: **6** (in.) Rod and Bar (Angled)  
Pipe Material: **DIP/CI** ☐ Pipe Lined  
Invert Depth: **6.50** (ft.) Flow Characteristics: **Slow**  
Deposits: ☒ None ☐ Mud ☐ Gravy ☐ Debris ☐ Grease  
Silt Depth: (in.) Deposits Extent:  
Infiltration: **Evidence** Pipe Seal Cond: **Cracked**

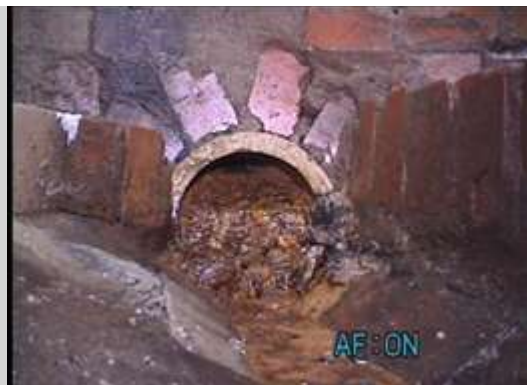
9 O'Clock Inflow

6 in. Circular Gravity Sewer  
Pipe In @ 9 O'Clock

Deposits: ☐ None ☐ Mud ☒ Sludge ☒ Debris ☐ Grease

Silt Depth: 5 (in.) Deposits Extent: Heavy
